Case Study for the Construction Repair of Destructive Skeleton Concrete Building by Lateral Forces

A. S. A. AL-Ameeri

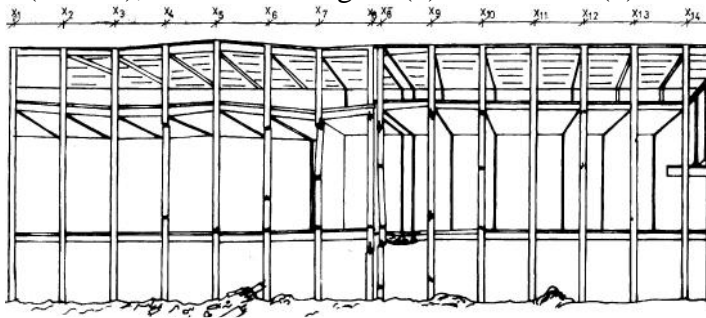
The buildings adjacent to the building in this study were destroyed as a result of bombardment with explosives, and this led to the failure of a set of columns which failed completely, and also to cracking of another set of columns, beams, and slabs which caused vertical displacement (Deflection) in the levels of beams and ceilings with different values for the various decks and beyond - in one of the areas to causing it to offset by 42.5 cm from the original level of the slab in the region of the column (X7-Y3), as shown in Figure (2) and Picture (1)

Figure 2. Graphic illustration of the building at the stage of the survey and pre-treatment

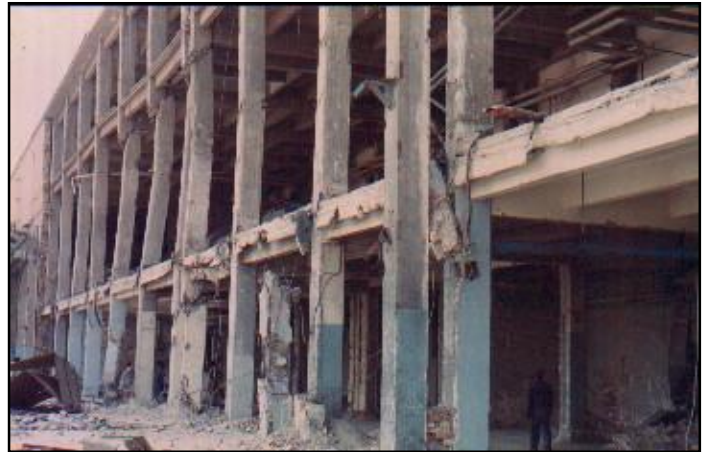
Picture 1. The state of the building during the initial pre-treatment (evaluation) stage.

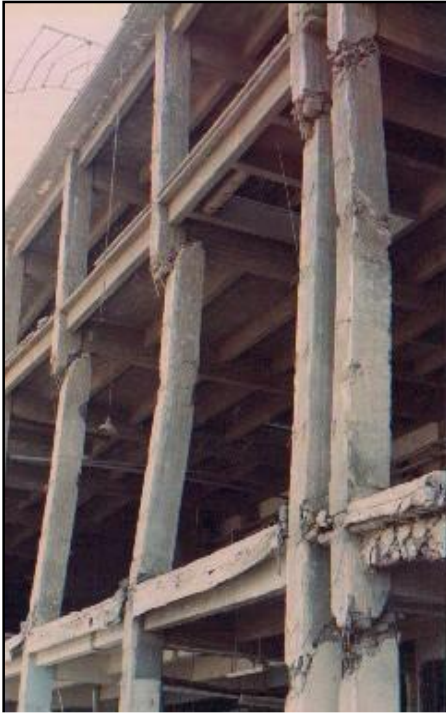
A - Columns affected by substantial damage (total failure), any breakup of the three areas of the end, the upper and the lower, middle and thus pushing the column from the end, or the upper to the bottom of the inside beams, as in the Picture (2), which generates a displacement in the level of beam and the slab for that area of various values, as shown in Table (1), and therefore require treatment

Picture 2. Samples of the columns affected by the substantial damage

to remove the broken columns, and to be near to the point of lift of the building.

The stage was of the process of crushing and removal of columns damaged completely (Full Failure) and where there was a vertical displacement and failure in the areas of connectivity with the beams with the plan to restore them later, as well as facilitating the process of lifting of the building, taking into account leaving the dowel bars from all ends of the top and bottom of the column where it

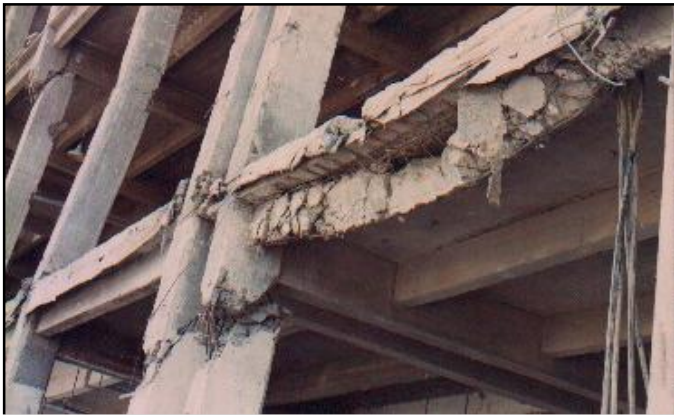
Although inspection of the slab showed some areas where there was minor damage, some areas such as those located between grids (Y2-Y3/X8-X9), were much more damaged as in Picture (3), which required removal and re-casting.

Picture 3. damage occurring from the slab and secondary beams in the slab, located between grids (Y2-Y3/X8-X9)

A-Beams and Slabs: this included treatment of cracks in the beams that had emerged after lifting by the same method in paragraph (3.2.4). The treatment of failure in secondary beams for the slab in the confined region (X8-X9/Y2-Y3) as shown in Picture (3), had been broken and re-cast with reinforced concrete with a compressive strength of grade 25N/mm² and the distribution of the same reinforcement as was originally used in the structural design of the building, taking into account the interdependence between the treatment of old concrete and modern concrete mixes by using Expansive Cement (Orchard -1979).

5 - Removing the damaged portions of the slab in the area bounded by axes (X8-X9/Y2-Y3) and re-casting with concrete with the same specifications and approved plans for the building design.

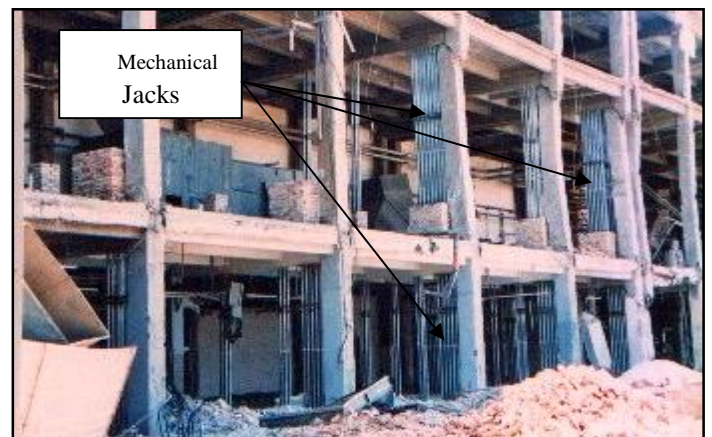
Picture 4. Building during the initial phase of the supporting by Mechanical Jacks

This phase required calculating the existing loads as shown in Table (3), by using Mechanical Jacks see Picture (4), because the building wasn't able to carry any vibrations' result removal the finishes floors of the work, especially the group of columns were had large damage, to provide safety work

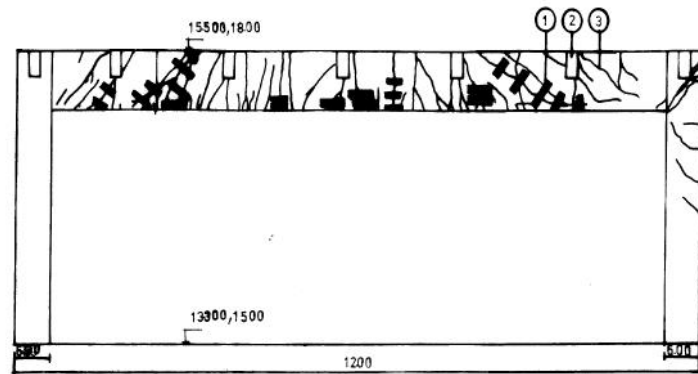
Because of the differences for vertical deflection, shear forces and bending moments caused stresses in the beams which thus got cracks in the most confined beams between the affected columns and the size of this damage depended on the amount of damage to adjacent columns, as shown in Figure (3).

Figure 3. Section in a sample of beam described by the types of cracks occurring and methods of Repair

- A - Injection (Epoxy Adhesive Resin -Type I) with low viscosity, and properties as in Table (2). The resin was selected to satisfy the American Society for Testing and Materials (ASTM C881-02) for shear and flexural cracks with width (0.5-1) mm (U.S. Army Corps Engineers- 2001) as shown in Figure (3).
- B - Injection (Epoxy Adhesive Resin -Type I) with fixed sheets of steel Plate width 5 cm and a thickness 0.5 cm, and a length depending on the location of cracks, by screws (Anchor Bolts), and perpendicular to the direction of cracks. This treatment was used for cracks greater than 1 mm (Minour-2001), as is shown both in Figures (3) and (4), in beams at ground and first floor beams on the axes (X4, X6, X7, X8, X8/, X9, X10).

- 1: The use of Epoxy with the installation of sheet steel width 5 cm and thickness of 0.5 cm to deal with crack widths larger than 1 mm.
- 2: Lintel secondary beam.
- 3: Use the Epoxy only to treat the crack widths less than 1 mm.

4 – Treating the beams along the damaged column axes by using Epoxy resin for cracks less than 1 mm, with the use and installation of steel sheet width (5 cm) and thickness (0.5 mm) by anchor bolts for cracks larger than (1 mm).

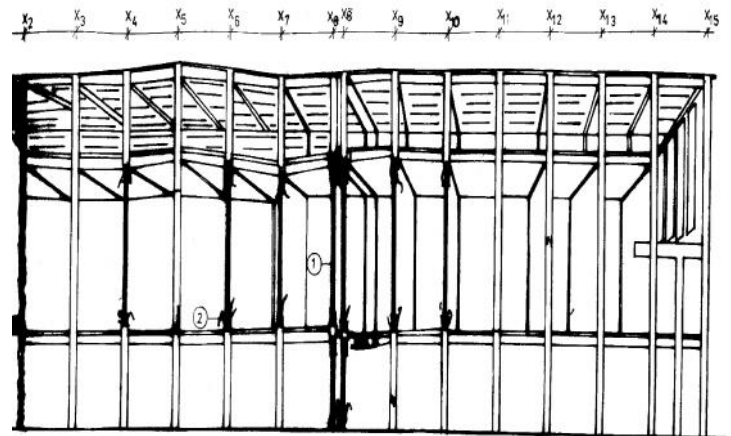
Figure 5. Graphic illustration of the building in the main supporting phase by the steel sections and lifting stage

During this phase the building was supported by using steel columns section. The section of this columns is consist of (HP14 *17) installed on base plates at upper and lower ends with a dimension (50*50*3 cm), and then insert in between the HP and the girder a built-up section in I-shape. This built-up I shape is consist of (W8X67) in web and welding to it two steel plates at the open sides and the same composite section will be used at flange as shown in Figure (5, 6), where the choice of these sections was not solely to prop up the building

- 1: A section of a steel column (HP14 * 17) with a base of sheet thickness 3 cm , 2: (Dowels Bar)

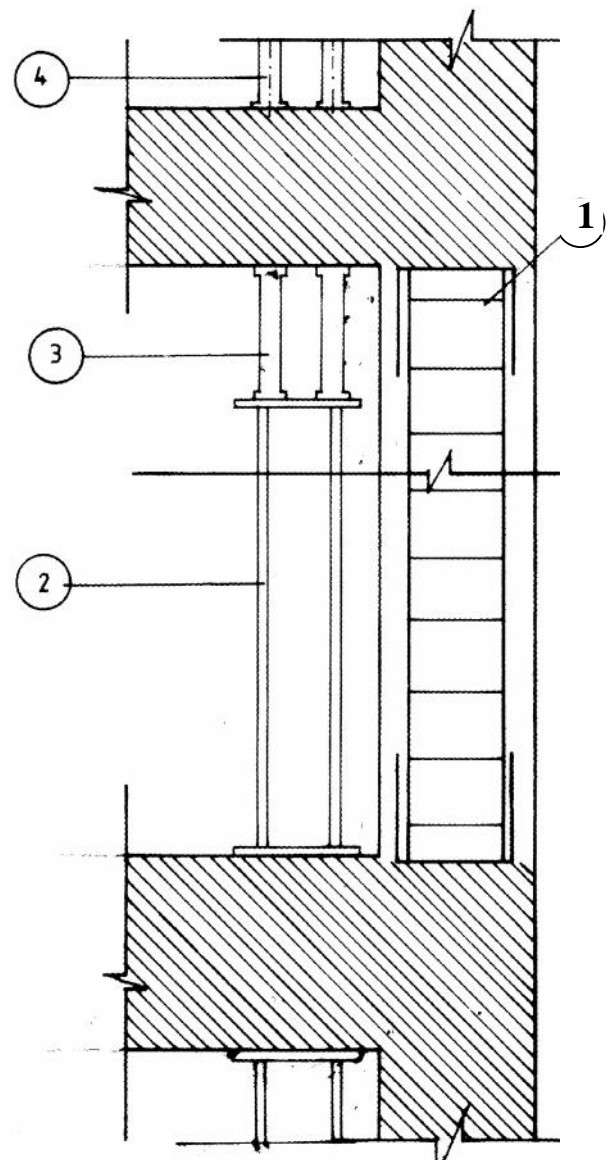
Fig 6. Graphic illustration for the side view of damaged columns during the supporting stage by steel sections, lifting and re-casting stage

1: The part that has been treated using expanded cement with link connection with dowel bars , 2: A column of steel section (HP14 * 117) with the base plate thickness 3 cm. , 3: The supports from steel built up section (W8 * 87) with plate thickness 1 cm. , 4: Mechanical jacks.

1 - Columns that were damaged completely by breaking down the columns shown in the Table (1), using the master plans of the building, the columns were replaced by columns of the same design, connected by dowel bars during treatment, as in paragraph(3.2.6) ,and then re-casting the concrete for the column with a compressive strength of grade (25N/mm²) with processing of the last half meter of the length of the column by using a mixture of concrete where it been contained expansive cement to connect between new and old concrete (Orchard -1979), and also shown in Figure(6)

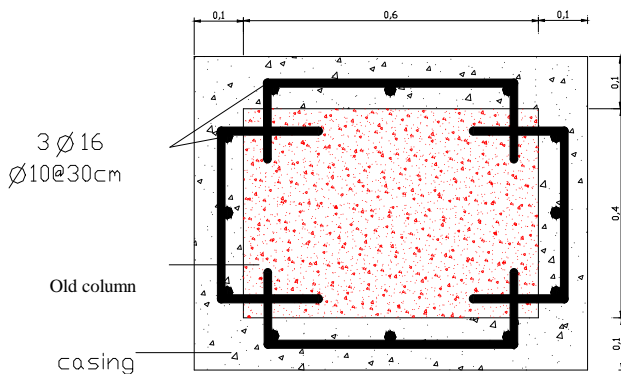
Figure7. Treatment of damage columns (simple) by using a casing of concrete

2- Columns with cracks: the ground floor columns, and columns on the first floor where it was processed by adding a casing (Ali -1998) , (Kadhim -1992) , by adding a layer to the dimensions of the reinforced concrete column from all directions, with rebars added to the annular and longitudinal steel, reinforcing the old concrete through punching the old concrete and rebar and drilling new holes in the treated areas to insert the new reinforcement in the floor, slab and columns, followed by grouting with Epoxy Adhesive as shown in Figure(7).

3 - damage to a few columns on the ground floor and on the axes (X6-Y2),, and the first floor on the axes (X5-Y3), (X11-Y3), (X12-Y3) and (X13-Y3), which was handled by the encasing with reinforced concrete of thickness 10 cm on the perimeter columns.
