# Fire and Explosion Hazards Expected in a Laboratory

### 3. CSS Committee Findings

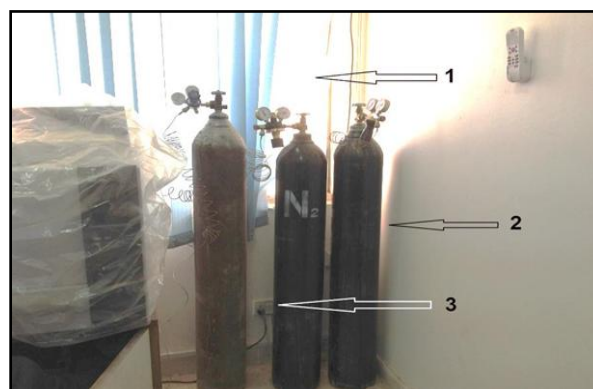
**Figure 1.** New GC with gas cylinders improperly installed, resulting in a number of safety hazards

- Cylinders are exposed to direct sunlight (Figure 1).
- Cylinders are not secured in place (Figure 1).
- There is insufficient space between the cylinders and they are not labelled (Figure 1).
- Tubing between the gas outlet on the hydrogen gas cylinder and the GC was improperly installed, which may lead to a gas leak (Figure 2).
- Fluorescent lights in the lab can spark (Figure 3).
- Laboratory operating instructions were posted too high to be read. (Figure 3).
- A local air conditioning (A/C) unit was present, which could spark. The main switch was between the hydrogen and nitrogen cylinders, making it hard to reach (Figure 4).

- Teaching laboratories dealing with hazardous gases must be equipped in a manner that minimizes staff and students' contact with such materials.
- Gas cylinders should be affixed to the wall using a chain, clamp, or other device.

- Laboratories should use hydrogen gas generators instead of cylinders wherever possible.

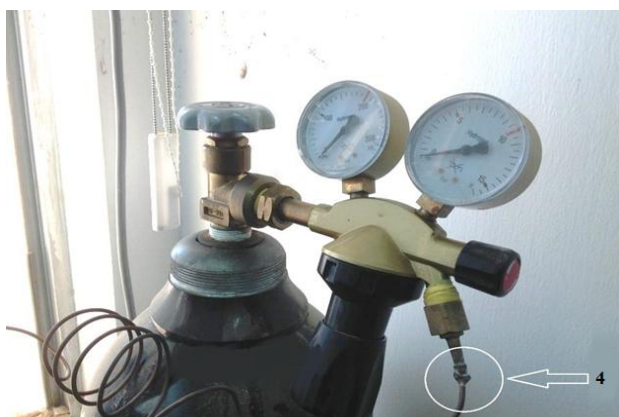
**Figure 2.** Improperly installed tubing between the gas outlet and the GC, which could lead to hydrogen leaks

- Tubing must be installed properly to minimize the possibility of leaks.
- Electrical components such as lights should be rated as explosion proof.
- Laboratories should be designed with central A/C instead of local units, which may spark.

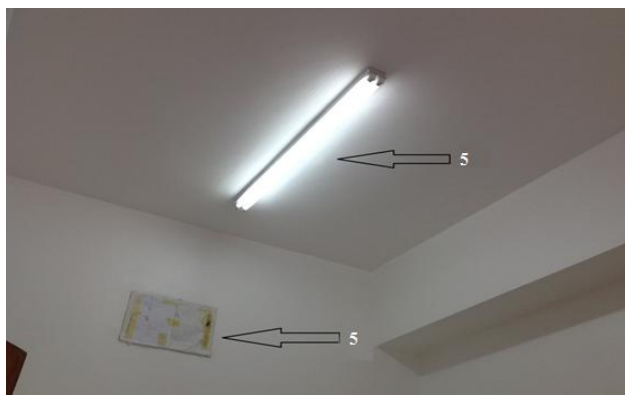
**Figure 3.** Fluorescent lighting installed in the laboratory and laboratory operating instructions posted too high to be able to be read

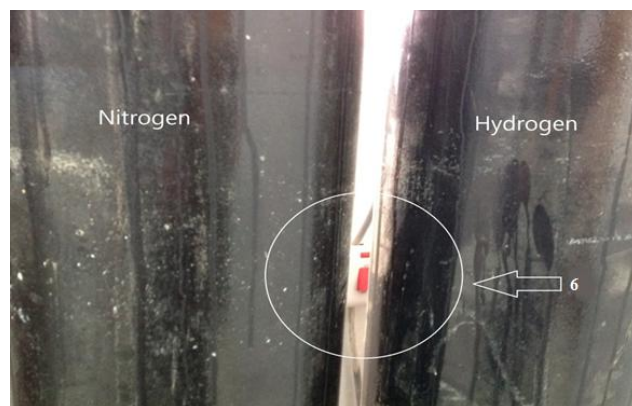
**Figure 4.** The main switch for the A/C was installed between the hydrogen and nitrogen cylinders
