Fire and Explosion Hazards Expected in a Laboratory

2. Incident Description

3. CSS Committee Findings

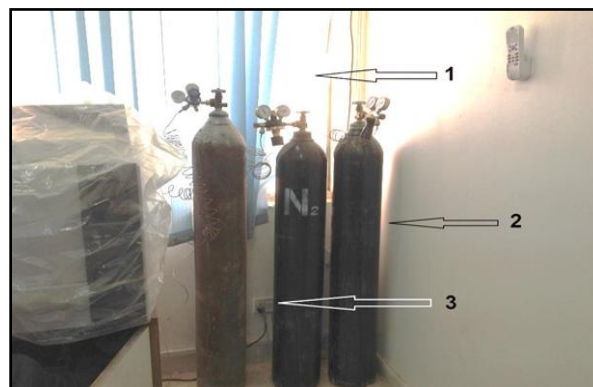
Figure 1. New GC with gas cylinders improperly installed, resulting in a number of safety hazards

- Cylinders are exposed to direct sunlight (Figure 1).
- Cylinders are not secured in place (Figure 1).
- There is insufficient space between the cylinders and they are not labelled (Figure 1).
- Tubing between the gas outlet on the hydrogen gas cylinder and the GC was improperly installed, which may lead to a gas leak (Figure 2).
- Fluorescent lights in the lab can spark (Figure 3).
- Laboratory operating instructions were posted too high to be read. (Figure 3).
- A local air conditioning (A/C) unit was present, which could spark. The main switch was between the hydrogen and nitrogen cylinders, making it hard to reach (Figure 4).

On the basis of the CSS Committee's findings, this laboratory was closed and removed from use by students and faculty until the safety hazards can be appropriately mitigated or eliminated entirely.

- Teaching laboratories dealing with hazardous gases must be equipped in a manner that minimizes staff and students' contact with such materials.
- Gas cylinders should be affixed to the wall using a chain, clamp, or other device.
