Investigating the Impact of Nano-Calcined Halloysite on Concrete Durability under Chloride Attack

Noor AL-Huda Hakim AL-Rubaie^a , Abbas Salim Abbas AL-Ameeri^a
Suhalia Mattar^b 1

^aEngineering College, University of Babylon, Babylon, Iraq

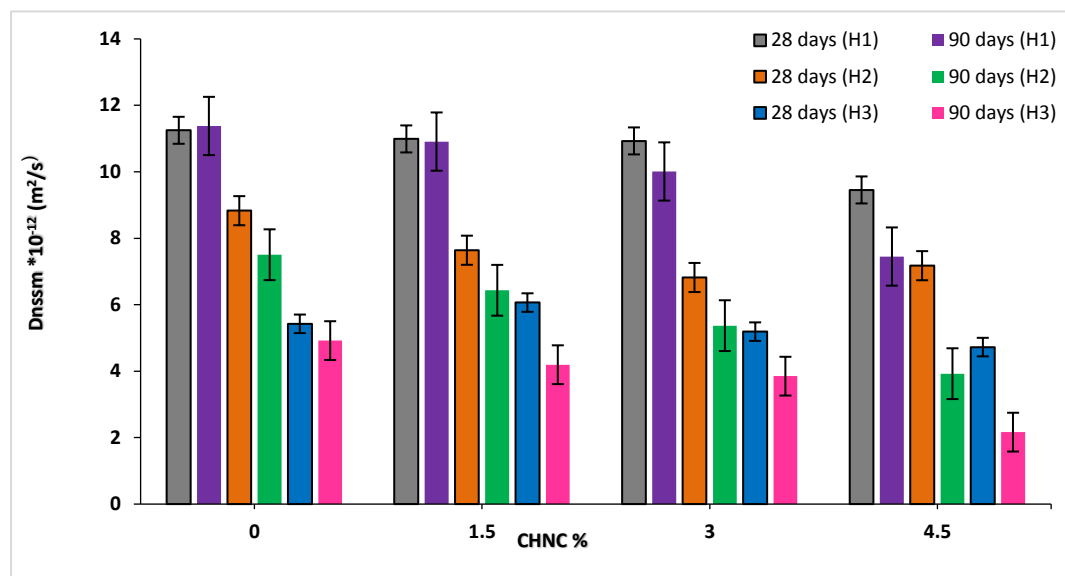
Figure.3: Chloride Migration Depth with CHNC Percentage at 28 and 90 Days

In Figure 3, the results of the chloride migration coefficient test at 28 and 90 days are illustrated. It is worth noting that the values of the migration of chloride depth at 90 days were less than the values at 28 days for all mixtures when the different percentages of CHNC replacement were increased as shown in Figure 4. There was a clear decrease in D_{nssm} in mixture H2, which is classified on high strength concrete; this decrease was 15% less than the control mixture at 28 days and this is because nanomaterials have a

great filling ability due to their small size, and can fill the pores by generating a gel [10]. The reduction in D_{nssm} for H3 mixture was 9.31% as compared to the reference mixture at 28 days in H1. This was due to the size of the GGBS granules; they are smaller than the cement particle. As such, according to the micro-filling characteristic of GGBS, they fill the voids in the microstructure of the cementitious paste and bind with the aggregate, making the concrete more compact and reducing the ability of aggressive materials to penetrate it [11]. This effect is clear in the results of the absorption test, which showed a clear decrease of 15.17% in the mixture containing GGBS at 90 days as compared with the control mixture .

Halloysite significantly reduced the migration coefficient as the replacement percentage increased. The results showed that the lowest diffusion coefficient was at the replacement of CHNC 4.5%. the D_{nssm} for H1 decreased by 21.21% at 90 days compared to 28 days, and by 45.30% and 54.18% for H2 and H3 respectively. This indicates that concrete containing halloysite is more resistant to chloride penetration.

The penetration of chloride ions primarily depends on the permeability and the microstructure of the concrete, and CHNC clearly reduces the permeability due to the decrease in the capillary pores of the concrete as a result of the continuation of the hydration process; the CHNC reacts with calcium hydroxide to form additional gel products that fill the pores, making the concrete is less permeable.

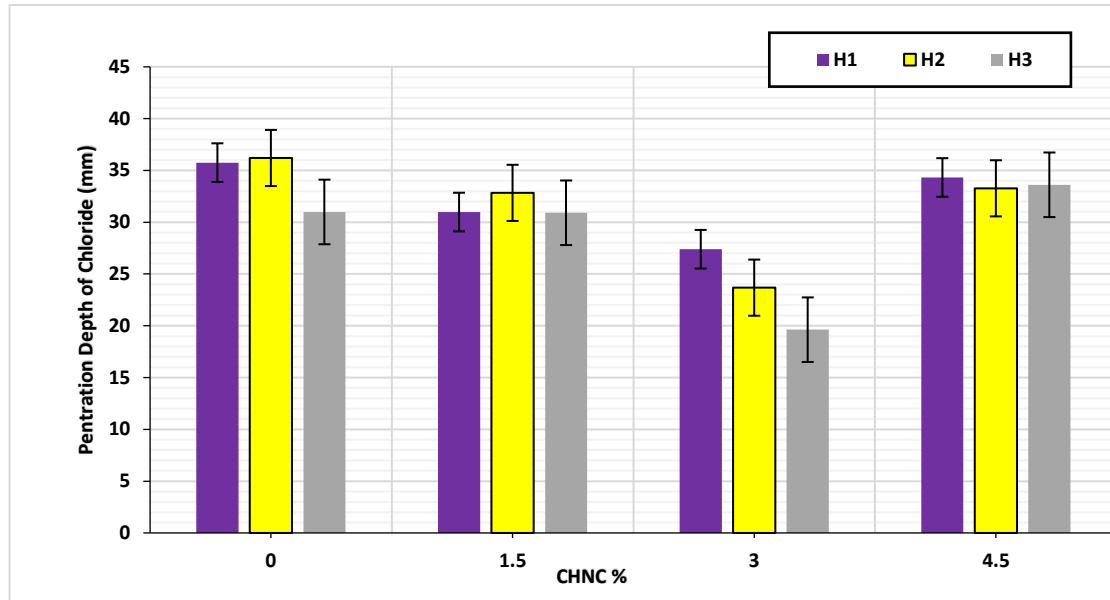
Figure.5: Depth Penetration of Chlorides for H1, H2 and H3 Mix

The impressed current test is an accelerated simulation of the corrosion process of reinforcing steel; it is an electrochemical process that determines the ability of halloysite to reduce the corrosion of a steel bar embedded in a concrete mixture. The penetration of chlorides into concrete is one of the primary causes of corrosion. However, result has shown that the incorporation of CHNC into concrete can reduce the amount of chloride penetration. Specifically, it has been observed that the amount of chloride penetration into concrete containing CHNC with concentrations of 1.5%, 3%, and 4.5% is lower compared to concrete without halloysite. It was found that the depth of penetration for all mixtures containing 1.5 and 3% decreased, though 3% was the best as the amount of decrease was 23.38 and 34.59 % for H1 and H2 mixture, respectively, as shown in Figure 5. This is due to the fact that CHNC reduced the pores in the concrete.

As for the percentage of 4.5%, despite the slight decrease in the depth of penetration as compared to the control mixture, its values were higher than those of the 1.5 and 3 % mixtures. This could be due the interaction of the halloysite with $\text{Ca}(\text{OH})_2$ to form new products of C-S-H; an excess amount of silica would form, which would accumulate to form large granules distributed inside the concrete, weakening the bonding between the components of the matrix and thus adversely affecting the concrete [12]. This behaviour is close to the behaviour of nano silica.

As for mixture H3, each combination of halloysite and GGBS had a significant effect, reducing the depth of penetration by 19.62 mm with a decrease percentage of 36.69%. This is because both halloysite and GGBS have the ability to fill pores, in addition, halloysite reaction with $\text{Ca}(\text{OH})_2$ which formed more C-S-H and the both effect means concrete very compact microstructure.

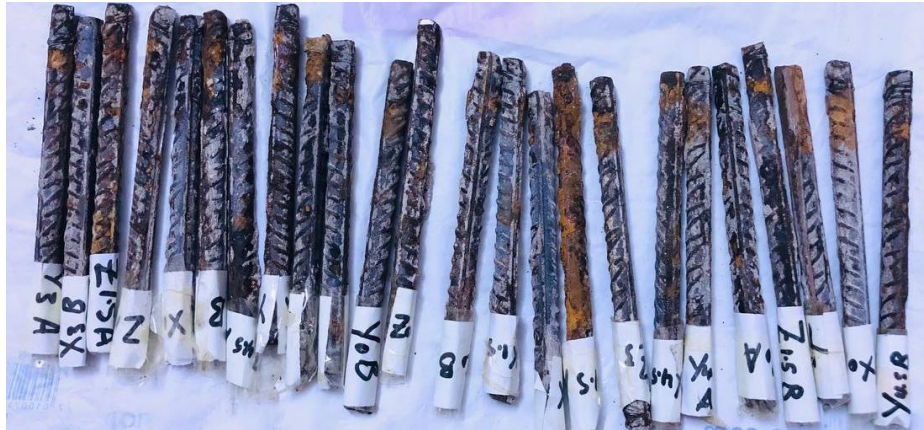
Figure 6: Corroded Steel Reinforcement

After the chloride ions reached the steel rebar, the protective layer of concrete began to be destroyed. The surface of the steel turned into an anode electrode and the electrochemical reaction took place. This was followed by the corrosion of the steel, and it turned to a colour ranging from black to red rust. Pitting was also observed on its surface, as shown in Figure 6.

6- The corrosion process was accompanied by a change in the colour of the reinforcing steel to a black to red colour, and pits form on the surface of the reinforcing steel.

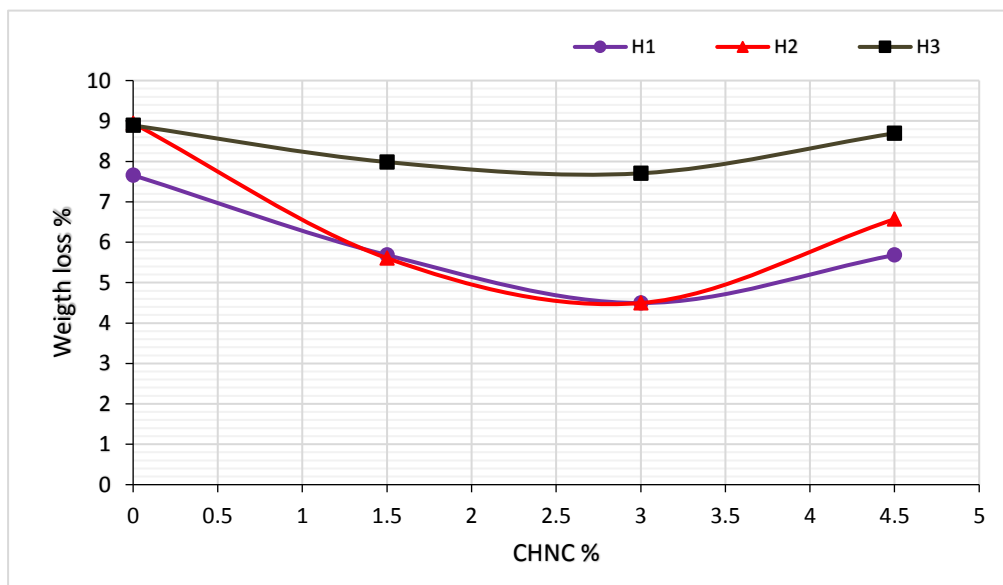
Figure7: Weight Loss of Steel Reinforcement

The weight loss of the steel sample provides a measure of the extent of corrosion that has occurred. The amount of weight loss in the reinforcing steel due to corrosion was determined by calculating the difference in weight between the initial weight of the steel sample and the weight after exposure to the corrosive environment. This weight loss can be calculated using the following equation 1

According to the findings of the study, the use of 3% of CHNC resulted in the lowest percentage of weight loss for all three concrete mixtures tested. This reduction in weight loss was particularly significant for mixtures H1 and H2, with a decrease of 41.30% and 49.74% respectively, while mixture H3 showed a decrease of 13.32% as shown in Figure 7. The results indicate that halloysite is effective in reducing pores and creating a dense matrix, which helps to preserve the reinforcing steel and reduce damage to the steel bar.

5 -The lower the penetration depth of the chloride, the less weight was lost in the steel bar.

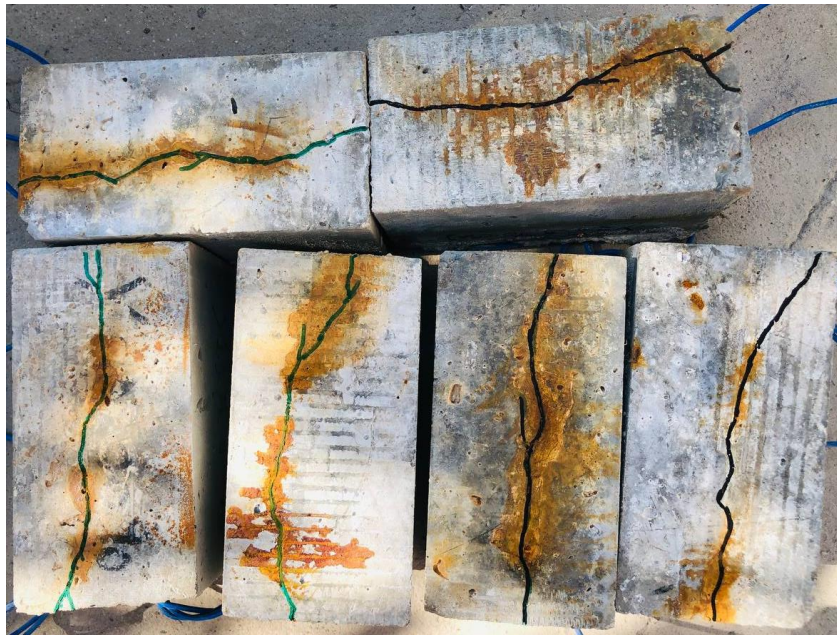
Figure 8: Crack Pattern for Concrete

As a result of the corrosion process and the formation of rust, pressure is generated on the area surrounding the reinforcing steel and cracks form along the face of concrete parallel to the reinforcing steel. Cracks also form on the sides of the area surrounding the steel bar, as shown in Figure 8.
