مشروع بحث التخرج

التحليل التركيبي والهندسي لتراكيب صخور تكوين انجانه-طار السيد/محافظة كربلاء المقدسه

Structural and engineering analysis of the rock structures of the Injana-Tar Al-Sayyid Formation, Holy Karbala Governorate

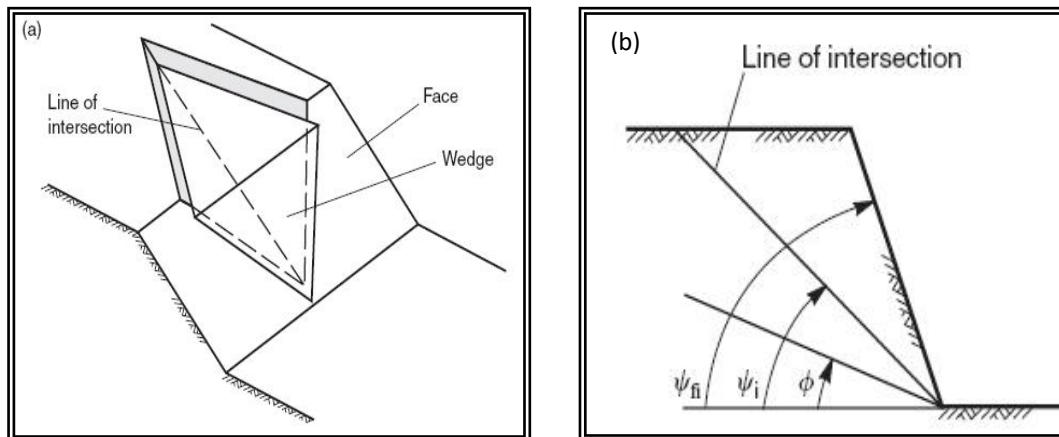
Wedge failure is concerned with the slope failure of a rock mass containing discontinuities striking obliquely to the slope face where sliding of a wedge of rock takes place along the line of intersection of the two planes. The general conditions for wedge failure are as follows:-
Wyllie and Mah, (2004) based on Hoek & Bray, (1981).

Figure (2-2) Geometric conditions for wedge failure: (a) pictorial view of wedge failure (b) view of slope at right angles to the line of intersection. Wyllie & Mah, (2004).

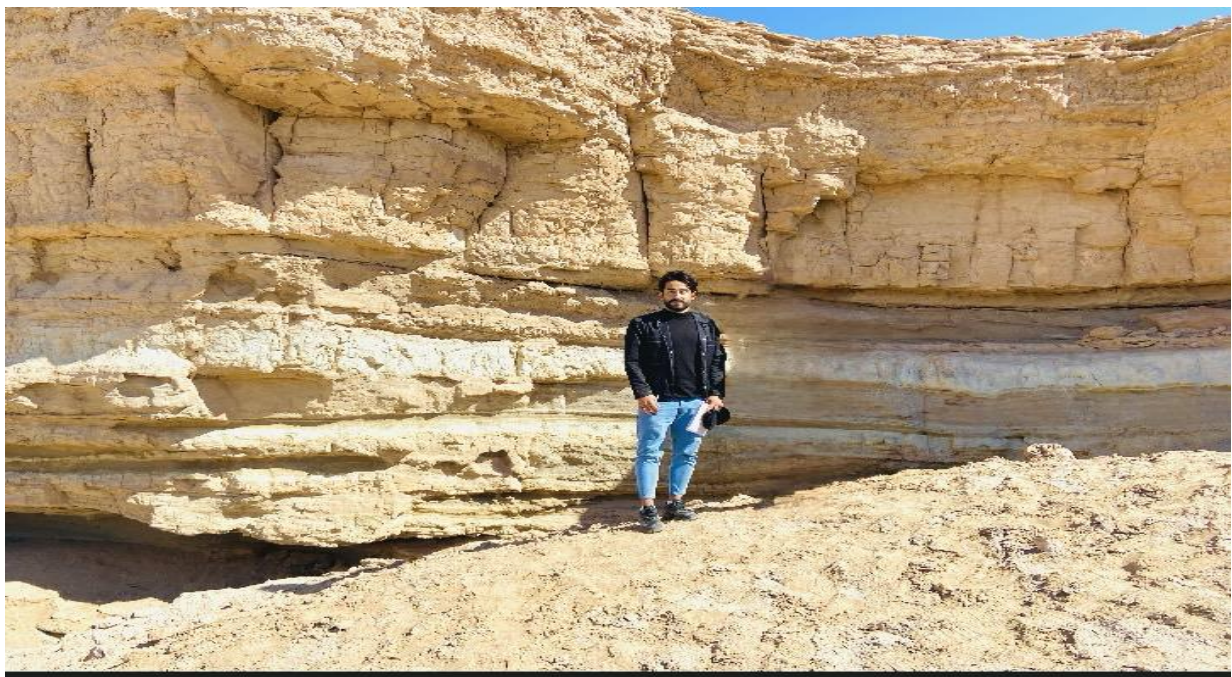
This station lies at latitude ($32^{\circ} 28' 28.78''$ N) and longitude ($043^{\circ} 46'.08''$ E), within Injana Formation, (Figure 1-2, plate 3-1). The slope is (6.0m) high, (9m) long along its trend , and its inclination is ($280/88^{\circ}$). The bedding plane is faint horizontal to sub horizontal inclination is ($210/6^{\circ}$). . Below the main rock slope, there is soil slope with inclination 20° NW covered by detached blocks.

Plate (3-1) The slope of station No. (1) (a) Front view showing detached rock blocks and discontinuities , Photo direction is SE (b) Top view showing tension crack. Photo direction is SE.

The rock mass layers consist of (2.75m) thick layers which are exposed. They are light pinkish orange , medium grained ,very thickly bedded, widely jointed, moderately weathered, pebbly SANDSTONE, moderately strong ($\sigma_c=14.85\text{MPa}$) and Slightly permeable .

There is a composite tension crack that consists of joints in (S1&S2) at the top of the slope, it is (4.80m) long, (0.3m) wide and (1.60m) deep, (plate 3-1-b).

The composite tension crack is open at the top slope . This makes the slope active and unstable, the rock slab bounded by this tension crack is likely to topple in the future by tension crack mechanism accompanied by undercutting due to differential erosion .

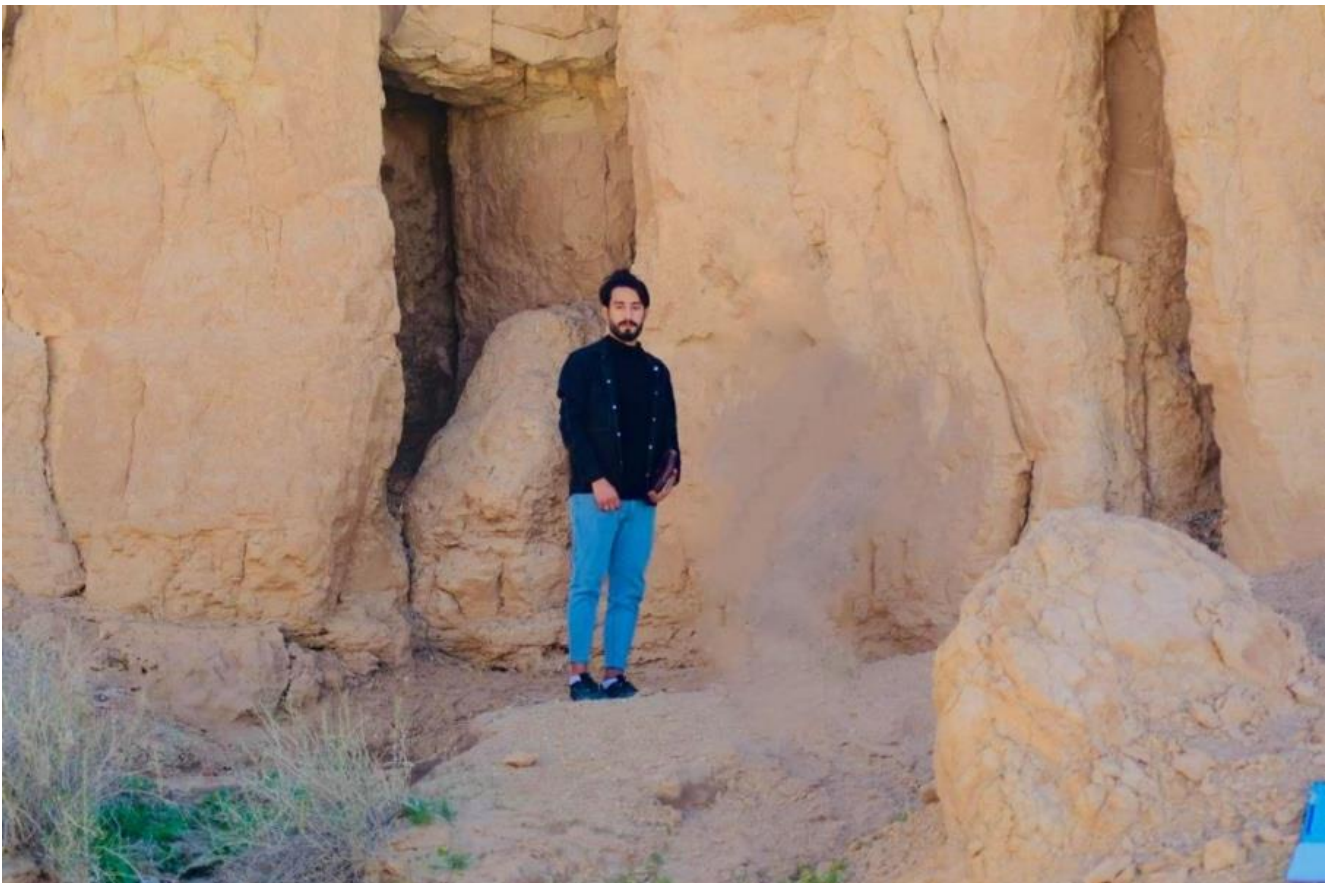
The underlying rock layer in the lower part of the slope (lower limit invisible) is exposed up to (0.6m) thick layers are light pinkish orange, medium grained, moderately bedded, moderately-highly weathered, SANDSTONE, very weak (failed in point load test). The lower part of the slope is largely exposed to undercutting leaving parts of the upper

slope overhanging.

Plate (3-2) The slope of station No. (2) (a) Front view showing detached rock block & discontinuities . Photo direction is SE (b) side view showing side slope and large toppled slabs. Photo direction is NE.

The overhanging parts are unstable and liable to failure in the future by secondary toppling type, by undercutting mechanism. Joints in (S1&S2) may act as Composite back release surfaces (CBRS), Joints in (S1) acted as back release surfaces (BRS) for the side slope and caused toppling for the large detached slab while those in joints (S2) acted as lateral release surfaces (LRS) . Rock fall has occurred in this station and likely to occur in the future in both slopes .The inclined soil slope helps rolling of detached rocks.

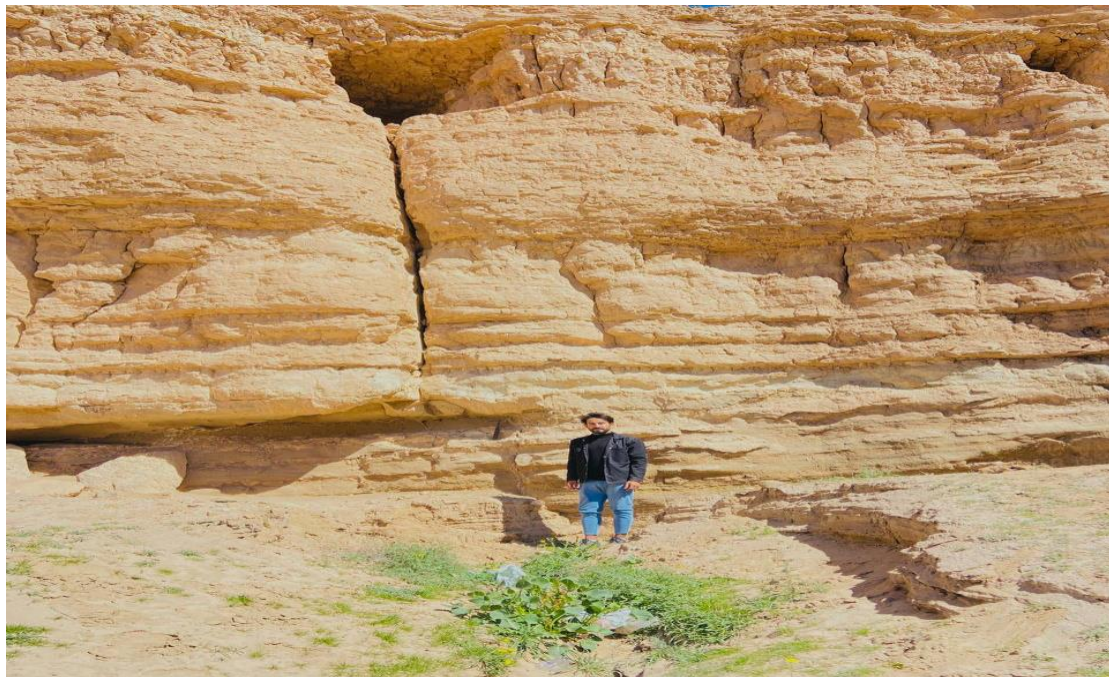
The rock mass layers consist of (1.30m) thick layer which is exposed. The rocks are light pinkish orange , medium grained , thickly bedded, widely jointed, slightly - moderately weathered, SANDSTONE, moderately strong.

Plate (3-3) The slope of station No. (3) (a) Front view showing general slope , detached rock block& discontinuities , photo direction is NE (b) side view showing side slope and, discontinuities . Photo direction is SE.

Failure may occur in the future by secondary toppling , due to undercutting accompanied by differential erosion in the lower parts of the slope 2 (left slope).During toppling and rock fall , in the general slope (slope1), joints in (S2) acted as back release surfaces (BRS), and joints in (S1) acted as lateral release surfaces (LRS), in the side slope (slope2), joints in (S2) acted as lateral release surfaces (LRS) while joints in (S1) acted as Back release surfaces (BRS) .

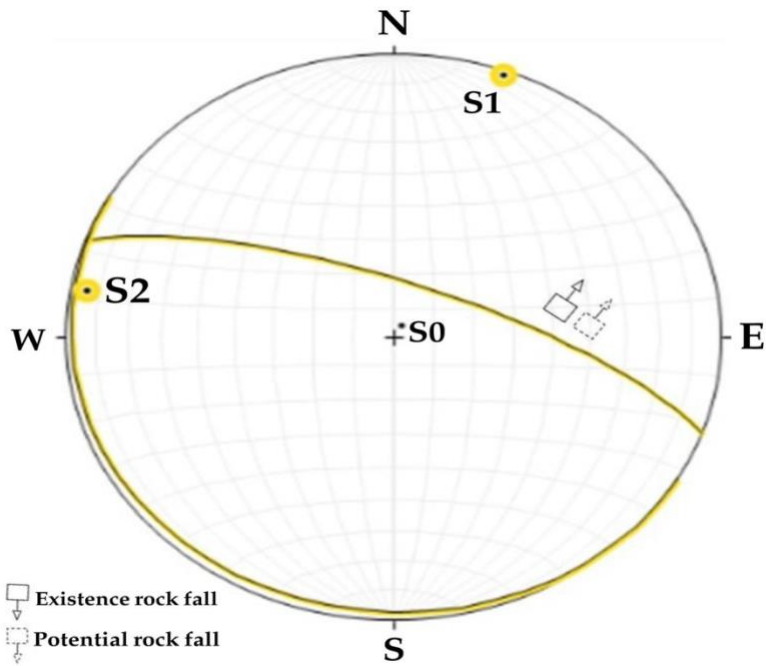
The sandstone layers are cut by two sets of subvertical joints in (S1&S2), (Figure 3-3). The average dip of S1 is (200/88 °) , and that of S2 is (100/88 °) .The spacing of joints in (S1) ranges between (1-2 m), their persistence reaches (1.30m) on the slope, they are almost tight . The spacing of joints in (S2) ranges between (0.5-1.0m), their persistence reaches (1.30m) on the slope and they are open about (0.04m) .

Figure (3-3) Stereographic projection of discontinuities, slope and type of failure for station No. (3) in Tar Alsayed area .
