Case Study for the Construction Repair of Destructive Skeleton Concrete Building by Lateral Forces

A. S. A. AL-Ameeri

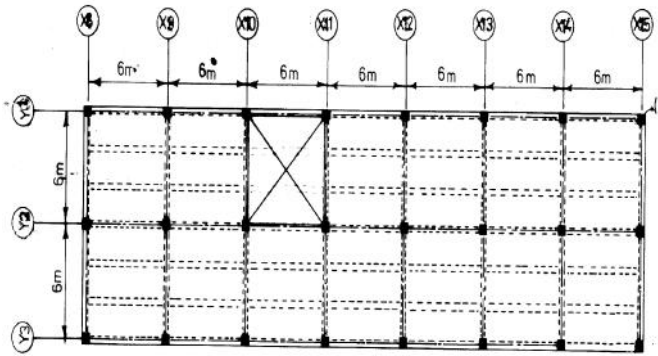
Figure 1.- The structural plan of the one part of the building

The buildings adjacent to the building in this study were destroyed as a result of bombardment with explosives, and this led to the failure of a set of columns which failed completely, and also to cracking of another set of columns, beams, and slabs which caused vertical displacement (Deflection) in the levels of beams and ceilings with different values for the various decks and beyond - in one of the areas to causing it to offset by 42.5 cm from the original level of the slab in the region of the column (X7-Y3), as shown in Figure (2) and Picture (1)
